REALISTIC PROBABILITY ESTIMATES FOR DESTRUCTIVE OVERPRESSURE EVENTS IN HEATED CENTER WING TANKS OF COMMERCIAL JET AIRCRAFT

***Norman Alvares, Fire Science Applications Inc., 751
Laurel St, PMB 431, San Carlos, CA 94070***

***Howard Lambert, Lawrence Livermore National
Laboratory, Livermore, CA 94550***

**5th International Seminar on Fire and Explosion Hazards, Edinburgh,
Scotland April 23 - 27 April 2007**

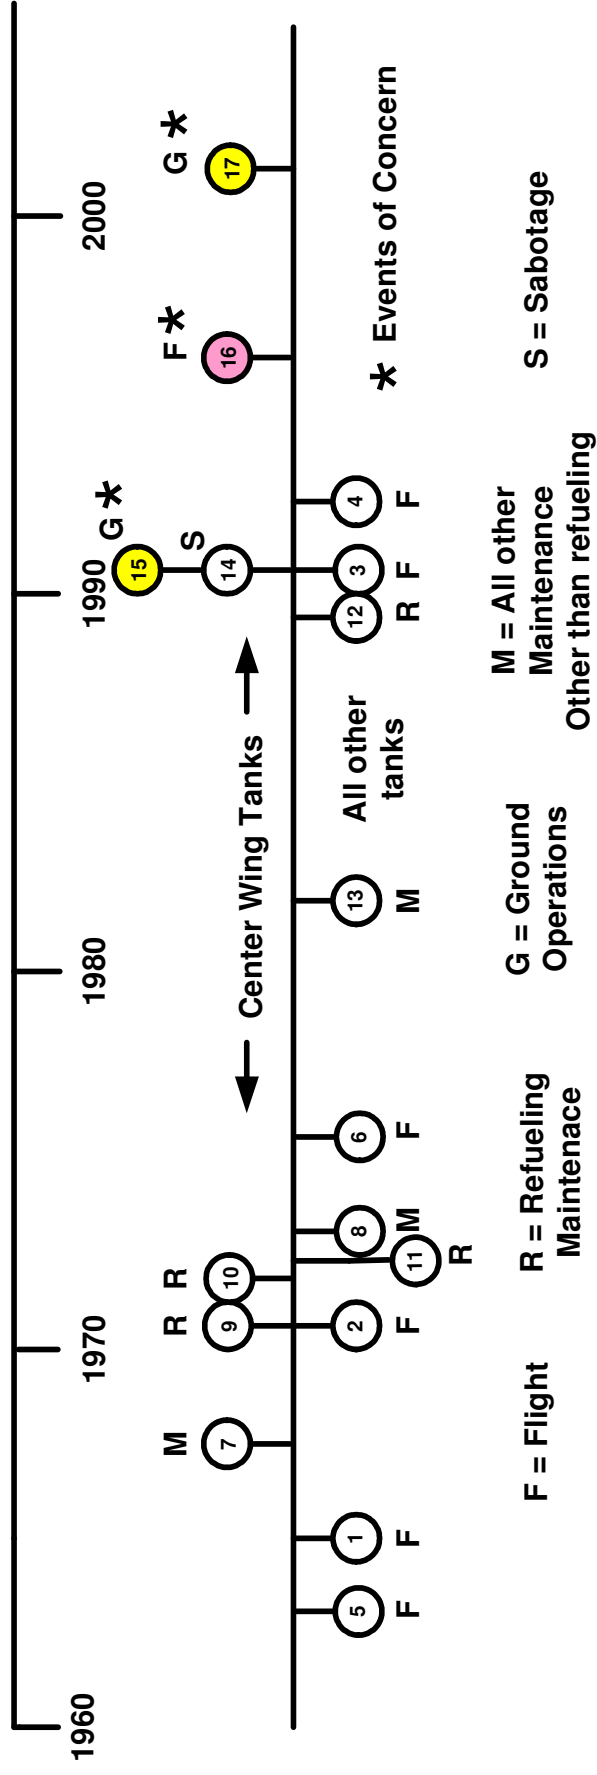
Time Line for Tank Explosions

* May 11, 1990, Manila, Philippines Airlines Boeing 737 (on-ground)

* July 17, 1996, New York, TWA Boeing 747-100 (in-flight)

* March 3, 2001, Bangkok, Thailand, Thai Airlines Boeing 737 (on-ground)

Most likely cause of on-ground incidents is dry running fuel pump.

- Eight events occurred in flight and ten events occurred on the ground
- Four events involved structural failure before ignition
- Two events occurred as a result of lightning strikes
